*IMPACT OF LEBANON BY-PASS  
1950 TO 1963*

*Joint  
Highway  
Research  
Project*

Highway Impact Studies:

Impact of Lebanon By-Pass 1950 to 1963

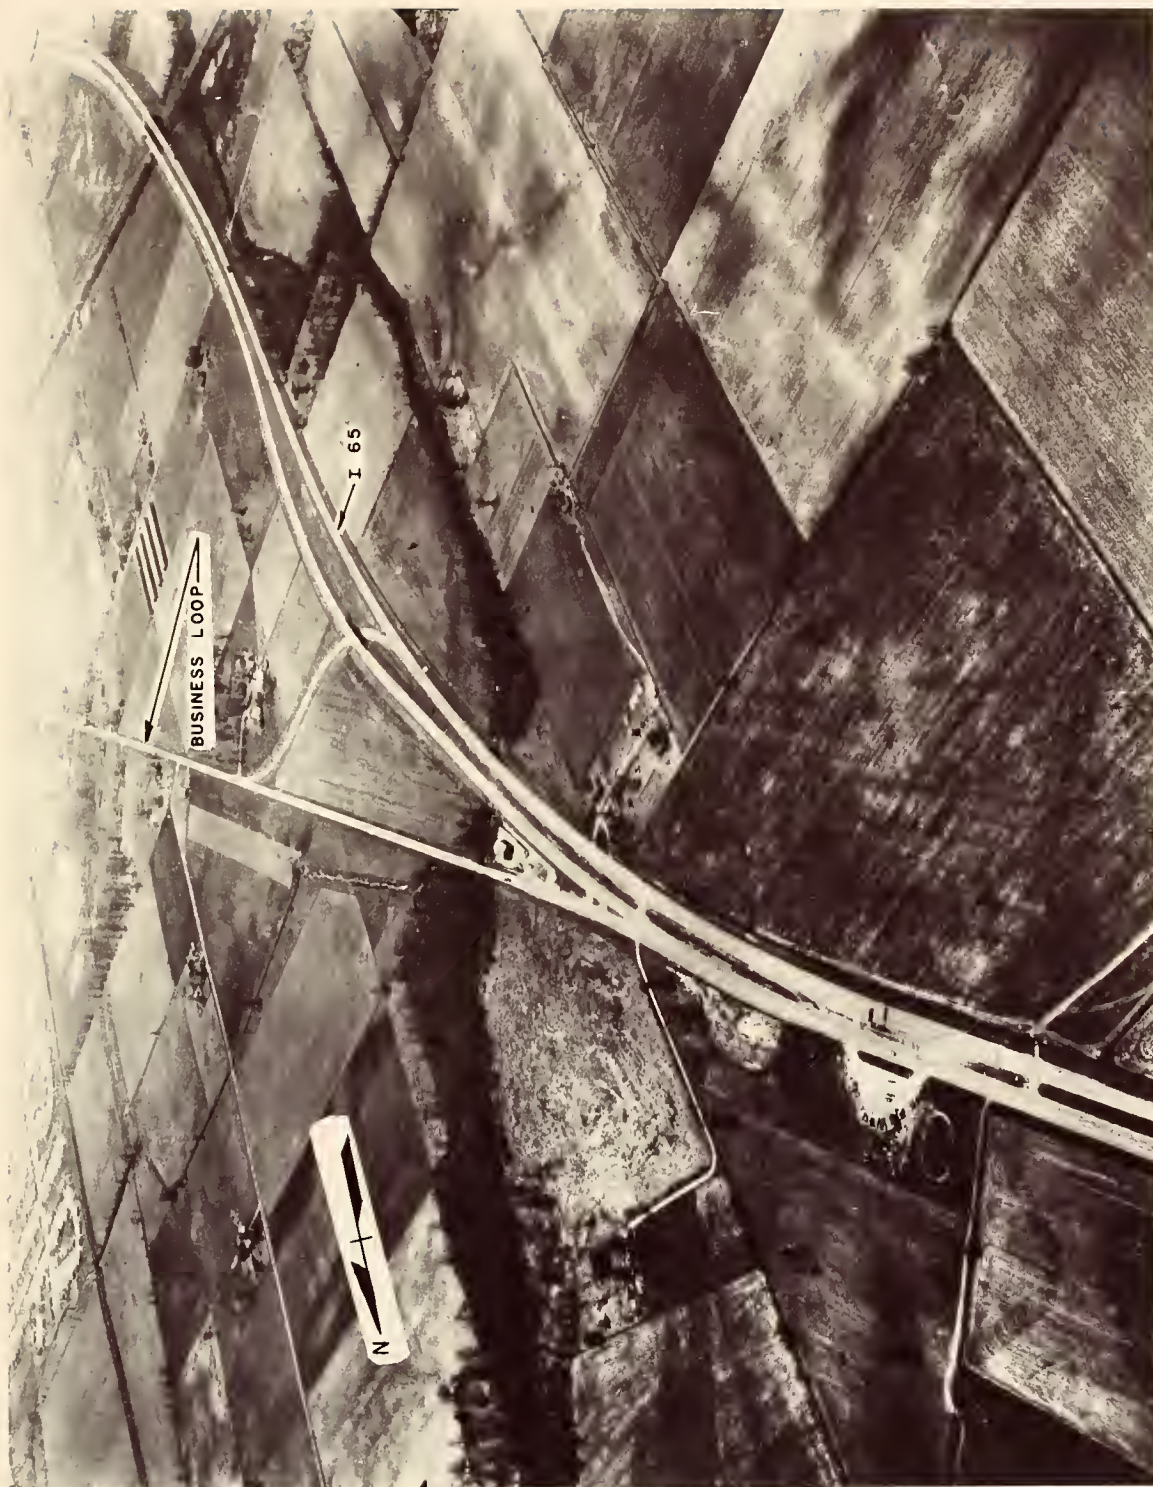
FIGURE 14

I 65-BUSINESS LOOP INTERCHANGE NORTHWEST OF LEBANON

PHOTO TAKEN APRIL 1963

By 1963 the By-Pass was completely reconstructed as a limited access facility as shown in Figures 14, 15, 16, and 17. A number of land use changes occurred because of the reconstruction (see Figure 18).

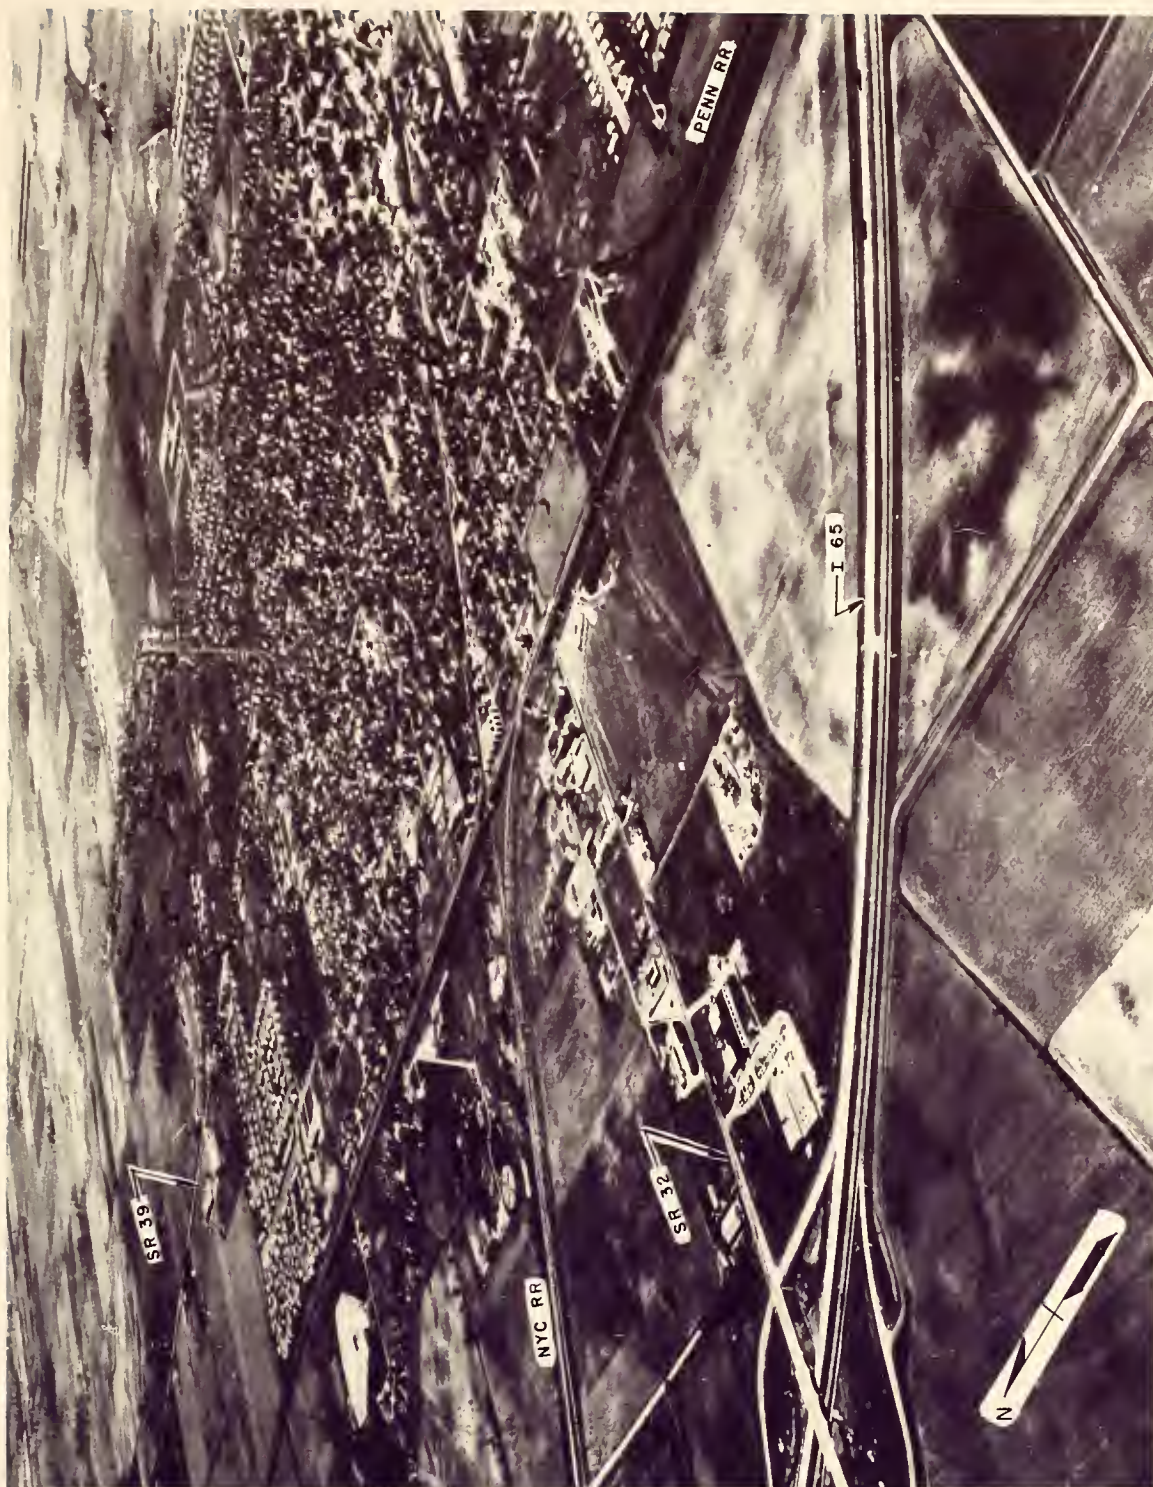
FIGURE 15

I 65 - SR 32 INTERCHANGE WEST OF LEBANON

PHOTO TAKEN APRIL 1963

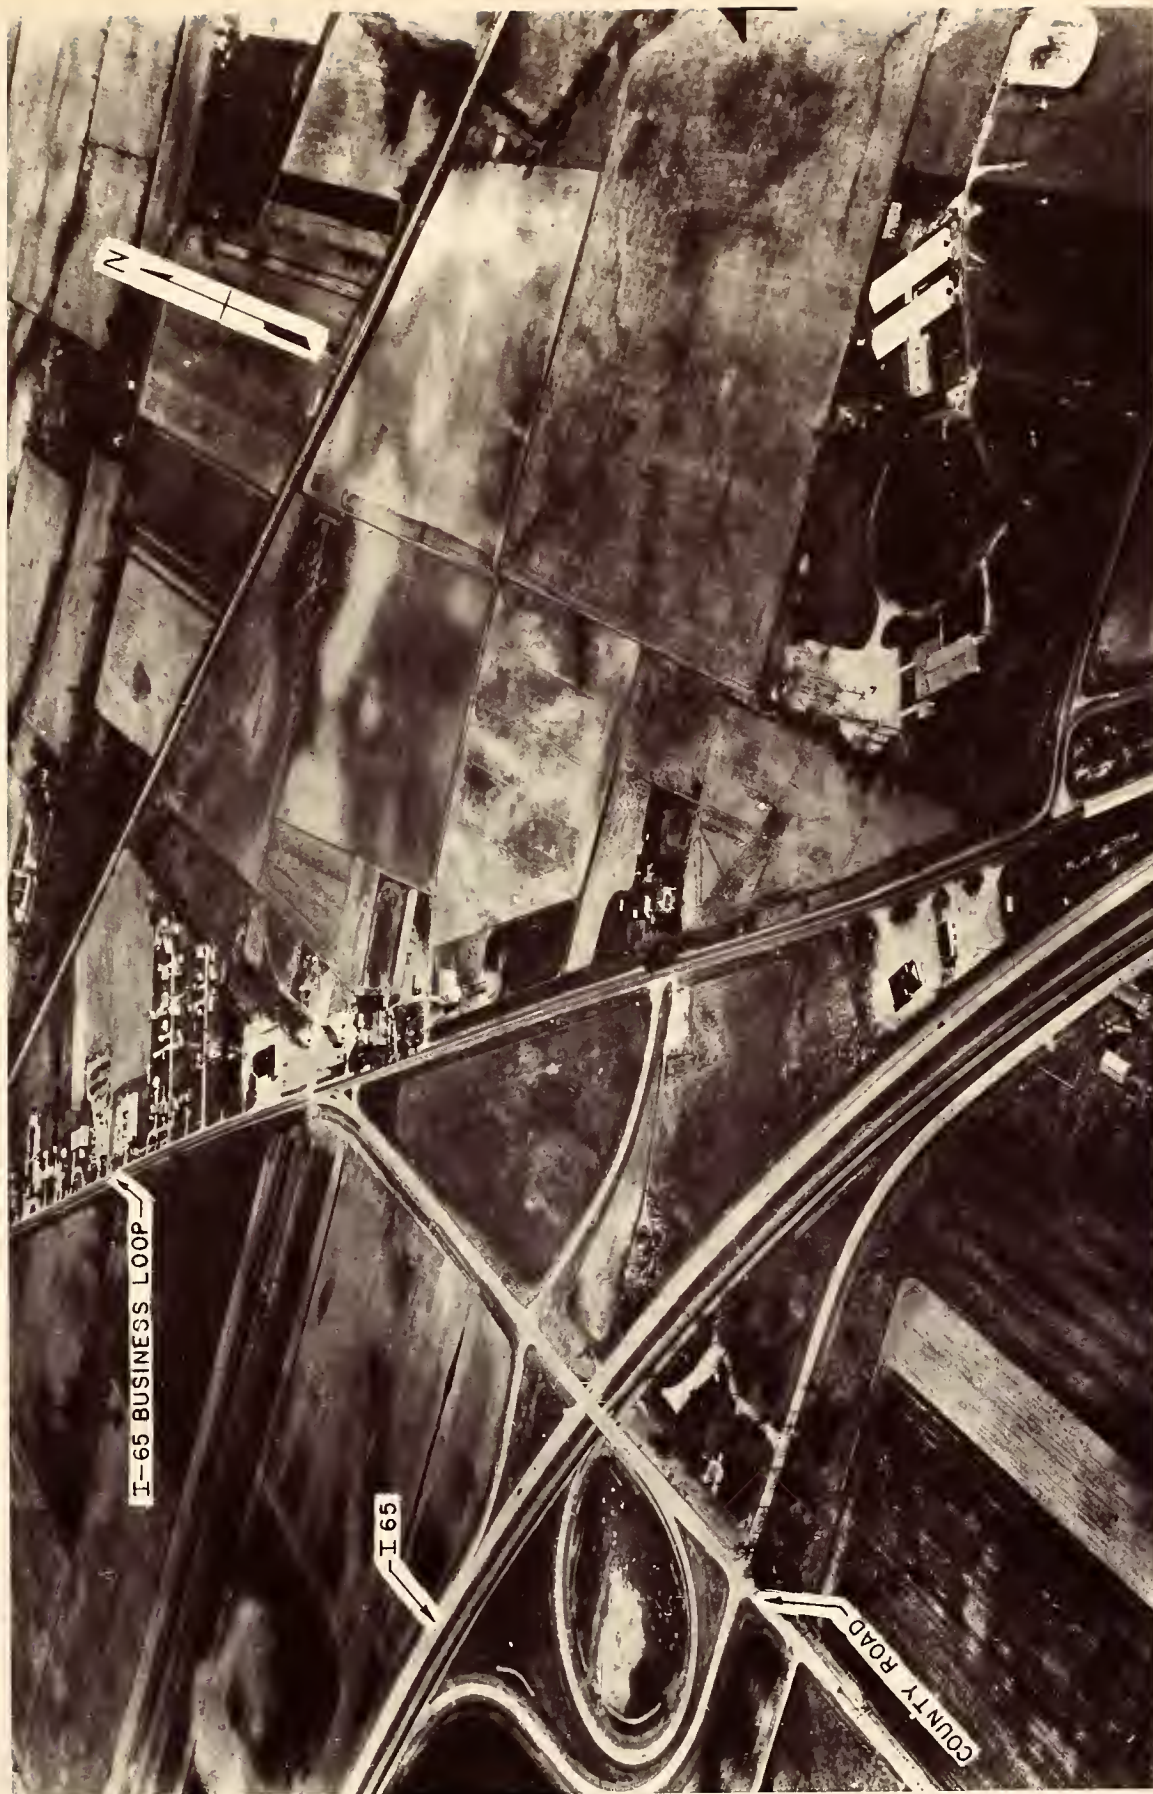
FIGURE 17

I-65 — BUSINESS LOOP INTERCHANGE SOUTH EAST OF LEBANON

PHOTO TAKEN APRIL 1963

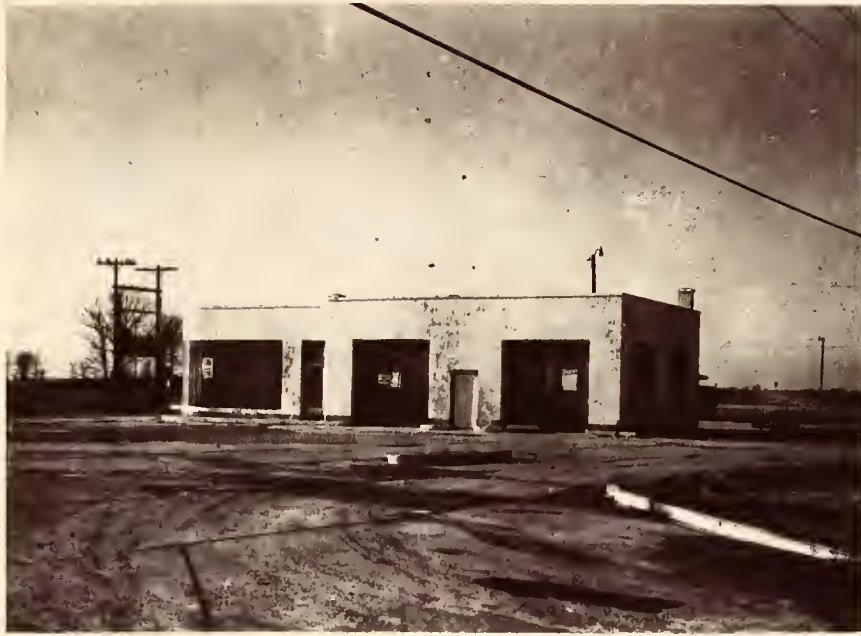
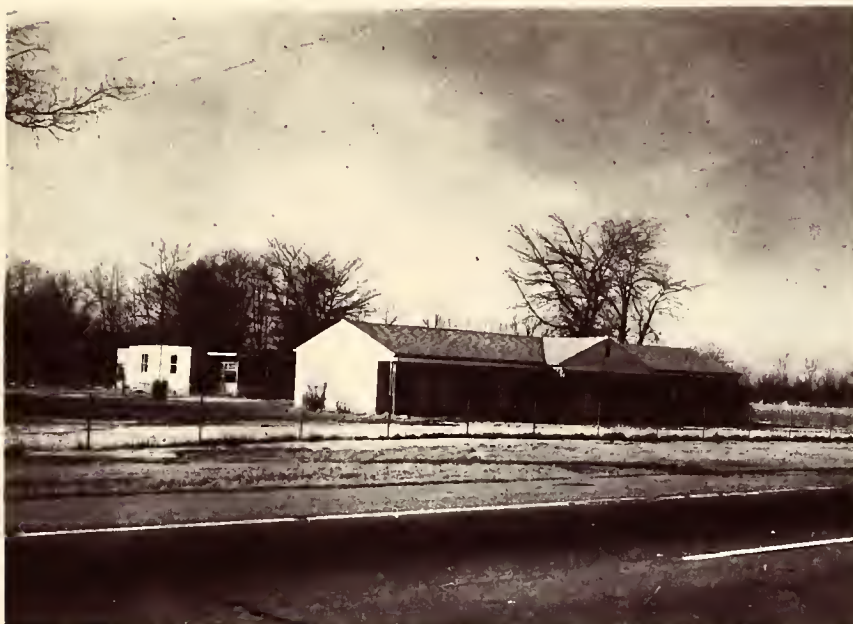
FIGURE 19

SERVICE STATION ABANDONED ON SOUTH END OF BY-PASS

MOTEL CLOSED ON NORTH END OF BY-PASS

BUILDING VACATED WHEN ACCESS WAS RESTRICTED

One motel and a service station were abandoned because access to the By-Pass was removed (see Figure 19). Interchange construction removed five service stations, two restaurants, and an auto sales agency (see Figure 20). Also removed and reconstructed on the remainder parcel was a farm implement sales agency. Access to the remaining motel was considerably restricted as shown in Figure 21. A restaurant located on the south end of the By-Pass closed two years after the limited access facility was completed but has since been rented as a lodge for a local fraternal organization (see Figure 22). The

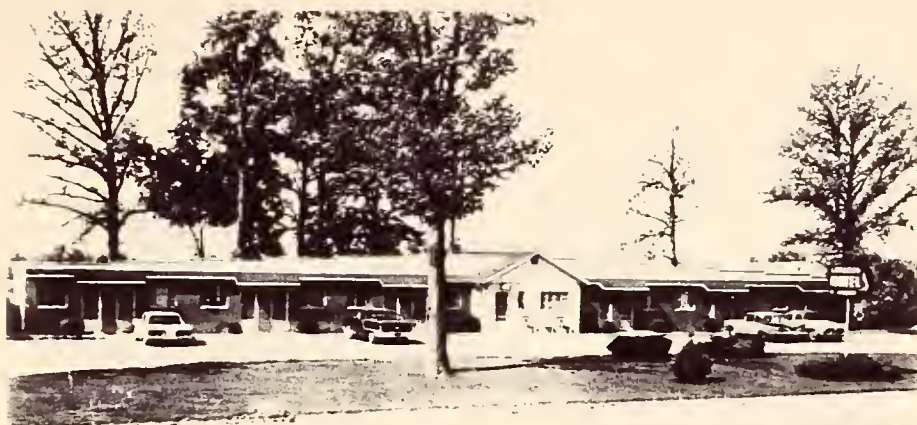
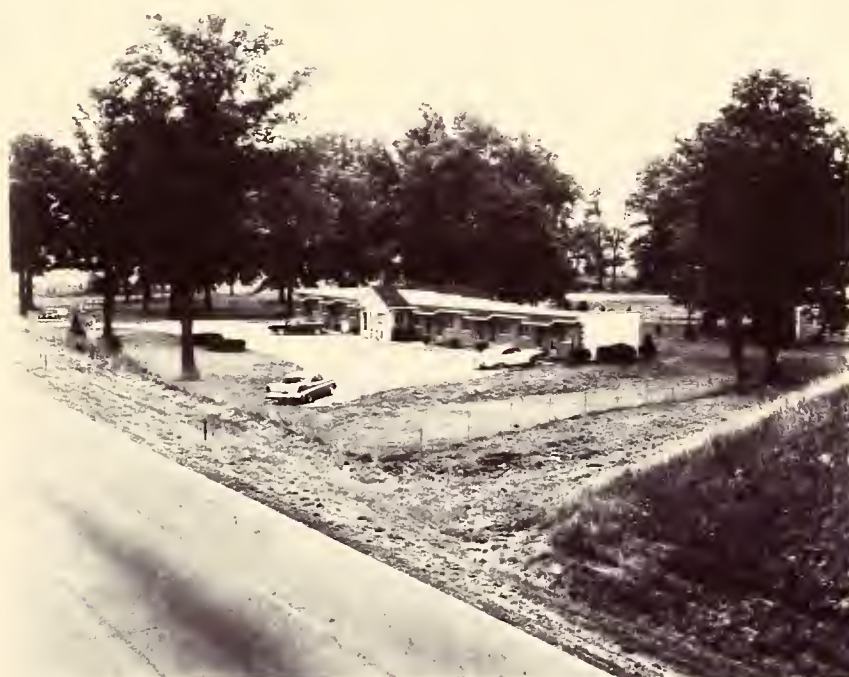
FIGURE 21

MOTEL WITH TWO DIRECT ENTRANCES PRIOR TO RE-CONSTRUCTION.

MOTEL WITH DIRECT ACCESS REMOVED BY RE-CONSTRUCTION. ENTRANCE FROM REAR.

MOTEL LOCATED ON SOUTH END OF BY-PASS

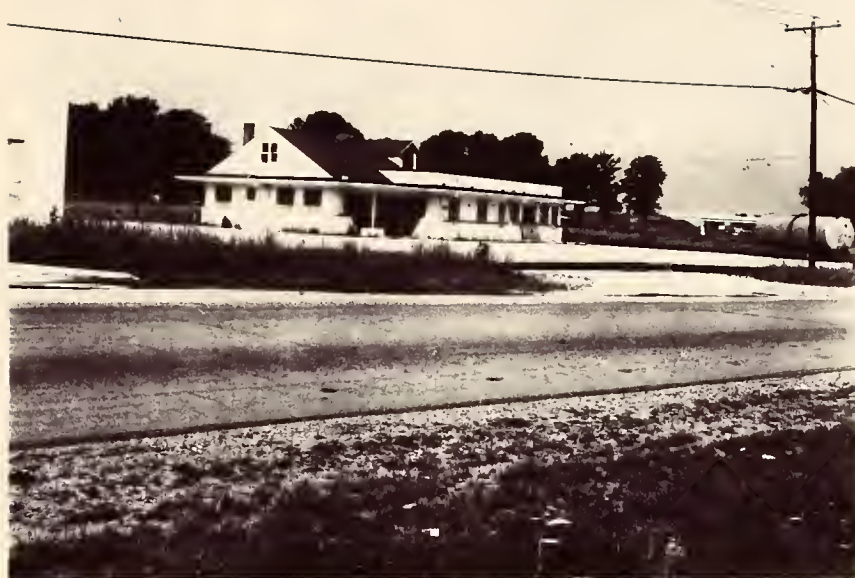
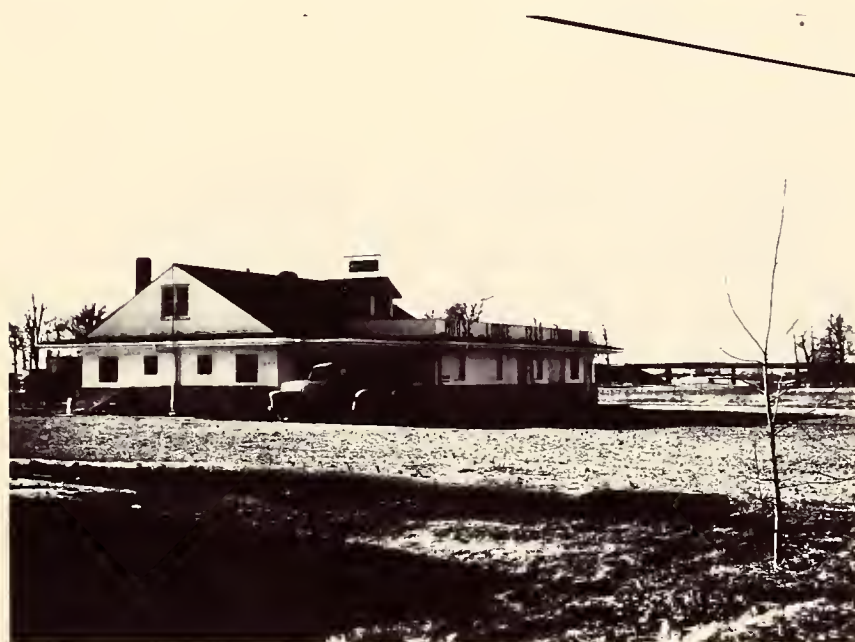
FIGURE 22

RESTAURANT CLOSED BECAUSE OF ACCESS RESTRICTION  
( 1961 )

BUILDING RENTED TO LOCAL FRATERNAL ORGANIZA-  
TION ( 1963 )

BUILDING USE CHANGED BECAUSE OF ACCESS RE-  
STRICTION

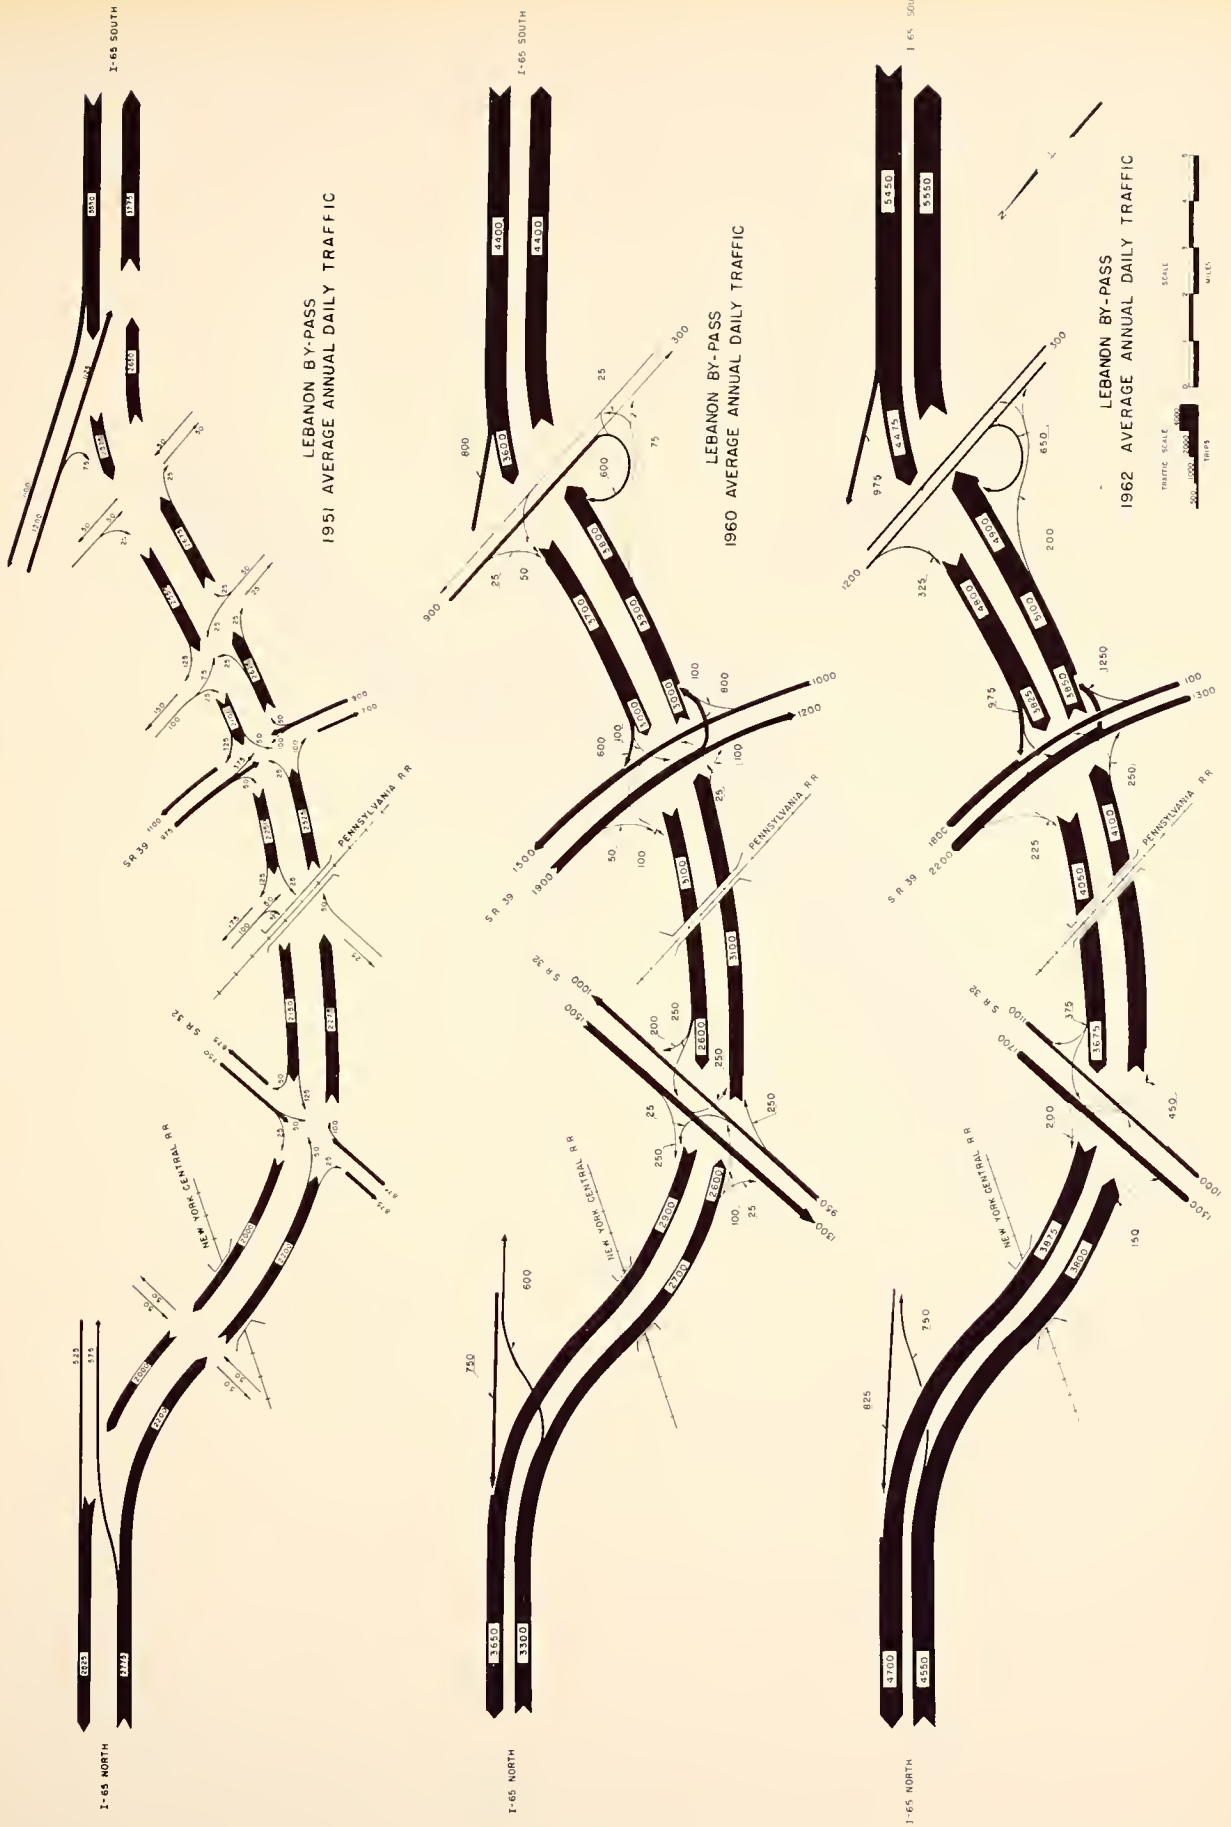
TRAFFIC VOLUMES ON LEBANON BY-PASS  
FIGURE 32

The decision to reconstruct the By-Pass as a part of I-65 resulted in the elimination of the congestion conditions that were affecting its usefulness. Access control eliminated eight at-grade intersections and replaced them with four interchanges. The resulting volume conditions indicate that a number of changes have occurred in the travel pattern (see Figure 32). The I-65 through traffic continues to use the By-Pass as shown in Figure 35. One of the noticeable changes, however, is that the SR 39 interchange has apparently replaced the city route of US 52 as the major south entrance to Lebanon. Entrance to the city on SR 39 might indicate that the drivers are missing the I-65 business loop exit, and thus use the next interchange. However, examination of the turning movements at the SR 39 interchange indicate that the majority of traffic using the ramps are either entering the city from I-65 northbound or leaving the city on I-65 southbound. The distribution of these turning movements would tend to indicate that local drivers prefer this interchange to the designated business loop. Further indication of this fact is that the volume on the business loop has decreased 30 percent since 1951 while the turning movements at SR 39 have increased almost 300 percent (see Figure 32).

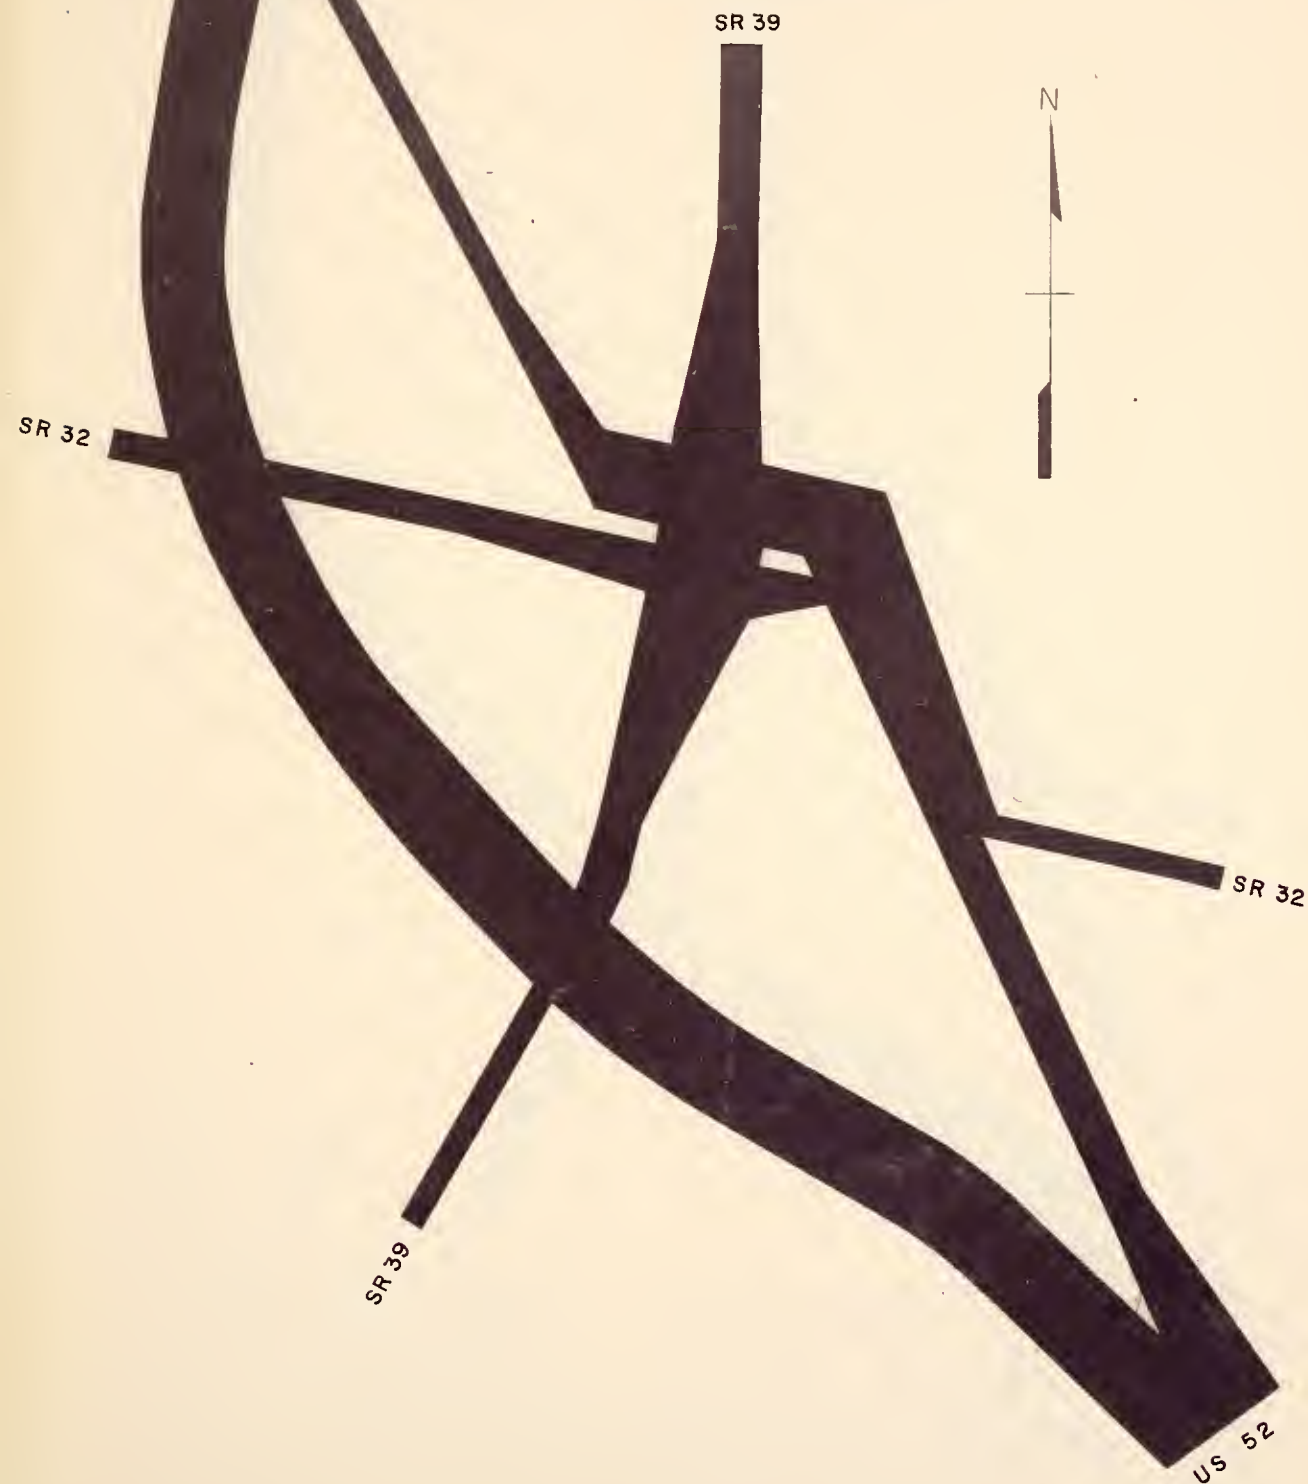
FIGURE 34

# TRAFFIC FLOW AT LEBANON AFTER THE CONSTRUCTION OF 2-LANE BY-PASS

1951

After the By-Pass was constructed, U.S. 52 traffic was diverted from the city route, intersecting both SR 32 and SR 39 at rural intersections (see Figure 34). This change greatly relieved the congestion that had previously delayed traffic within the city. The traffic volumes of SR 32 and SR 39 were not appreciably affected by the diversion. The rural nature of the By-Pass intersections with SR 32 and SR 39 and the increasing volumes both on the State routes and on the by-pass led to the installation of traffic signals at these intersections two years after the facility opened.
